## Introduction

## How defect assessments are conducted

## Visual/Surface Imperfections in Glass

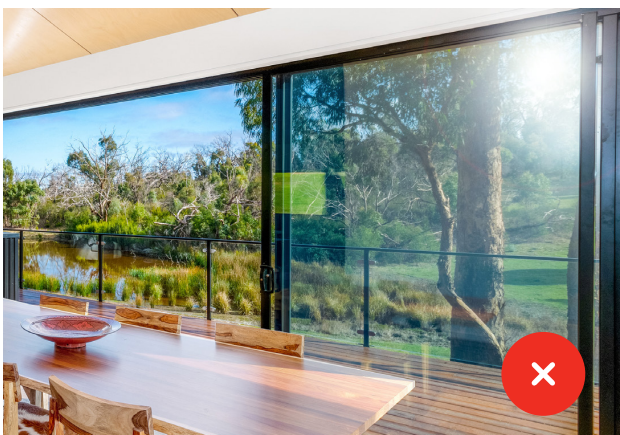
### Image: Incorrect viewing position, in direct sunlight

- Glass should not be in direct sunlight during the inspection.
- There may be minor variation based on State-Based Legislation or contractual conditions.
- Not only is the viewing distance and angle important, so to is the type of daylight you're looking into. Certainly, the glass can be viewed in the daylight, but it must not be direct sunshine.

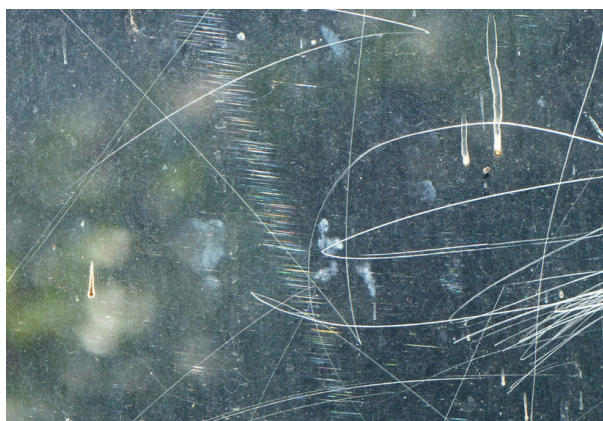
#### Image: Scratches on Glass

Surface scratches on the glass are, without a doubt, the most common problem. A sharp or rough instrument may cause marking or tearing of the glass surface.

In respect to as Low-emissivity (Low-E) glass the coatings are actually harder than the glass and consequently is quite difficult to scratch. However, the marks might be abrasion marks. The consequence of the coating being very hard is that it can abrade other materials. So, materials rubbed across the coating can abrade and leave deposits on the surface. These abrasion marks can be cleaned off using the manufacturer's recommended procedure.

Scratches should not be visible from 3 meters or more. For the maximum allowable number of scratches in primary and secondary vision are of IGU refer to Table 5.5 and 5.6 of AS 4666.

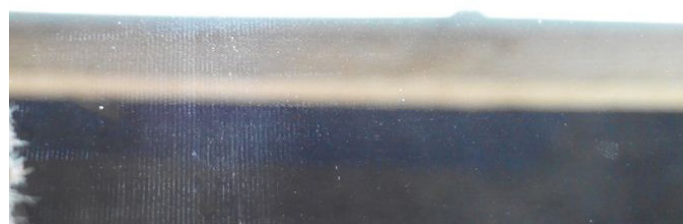
#### Image: Haze on Glass

Haze (a light and milky effect) is the scattering of light rays when visible light passes through a transparent material like glass. Haze can appear on coated glass such as Low-emissivity (Low-E) or laminated glass or tinted glass. The amount of haze in ordinary glass is very low and is not detected by the human eye. Haze is a characteristic that is a common consequence of the crystalline structure of the coating. Some of the light that enters glass is absorbed, and some scattered by components within the glass. If sufficient light is scattered, then it will appear as a haze in the glass. The visibility of haze depends on two criteria: the surrounding conditions and the brightness of the background.

It is possible for a glass product to exhibit haze at certain times of the day and not at another. It is also possible for the same type of glass to display haze in one location and not in another. With any coated glass, it is possible to see the presence of the coating under a certain angle and intensity of the lighting. Haze sometimes has the appearance of a blue-grey film or dust on the coated glass. Haze can occur in both clear and coloured laminate, with it more evident in grey laminate. Haze is very dependent on the angle and intensity of the light. Some colour variations such as a blue haze may exhibit in Low-E glass, especially noticeable if part of the glass is shaded.

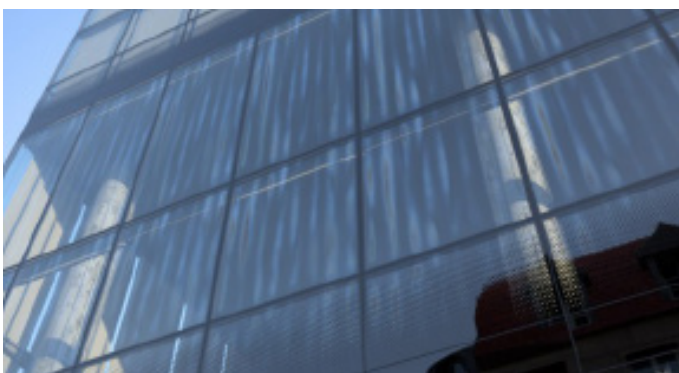
### **Images: Examples of Anisotropy**

While these sounds technical, it simply means where glass surface can appear alternately light and dark (sometimes known as 'leopard spots') when polarised light is incident on it. The effect can be accentuated when there are two or more layers of toughened glass in an IGU. The marks are often most visible in particular lighting and when viewed through polarized sunglasses.

**Anisotropy is not considered a defect and an inherent part of the tempering process.**

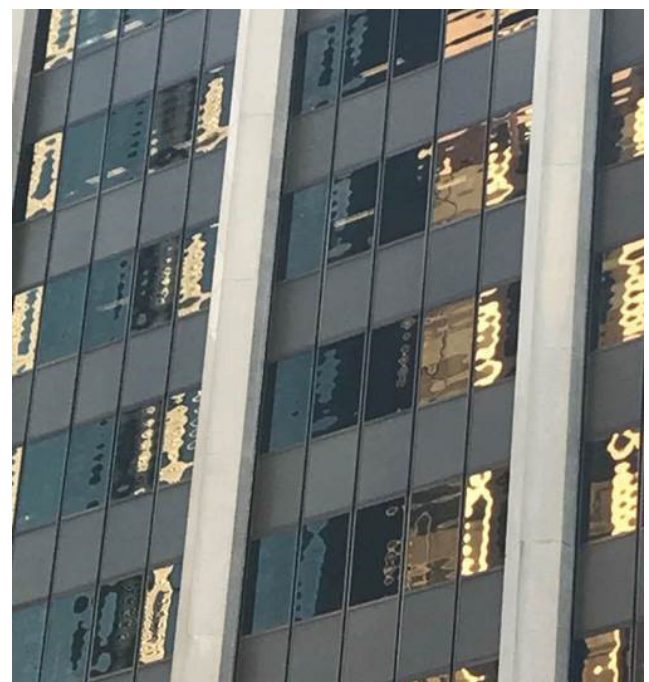
### **Image: Roller wave on building windows**

Roller wave can be seen in toughened and heat-strengthened glass. Glass is generally toughened in a horizontal roller hearth furnace, where glass is carried through and oscillated on ceramic rollers under high heat (approx. 600°C) at this temperature glass starts to soften and can therefore creep between the rollers causing alternating high and low points resulting in the glass exhibiting optical distortion.

**This distortion is more noticeable in reflective or dark tinted glass. This distortion is also more noticeable in thinner toughened glass, for example The roller wave distortion is more visible on 4 mm toughened glass than say 6 mm toughened glass.**

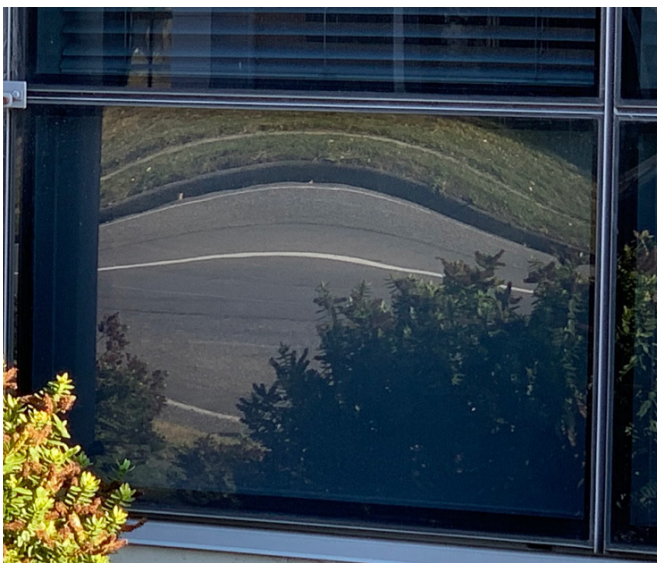
Small changes in temperature and pressure can cause the glass to bow outwards or inwards and change the images reflected from the window, as shown in the image on the right. These distortions are unavoidable and cannot be eliminated. The use of thicker glass will reduce glass deflection under wind loads.
